Shot firing the Plasco Building and Reasons for the collapse

Seyed Mohammad hosein kataeian¹, Mohsen Gerami^{2*}

¹ MSc Student of Earthquake Engineering, Department of Earthquake Engineering, Semnan University, Iran

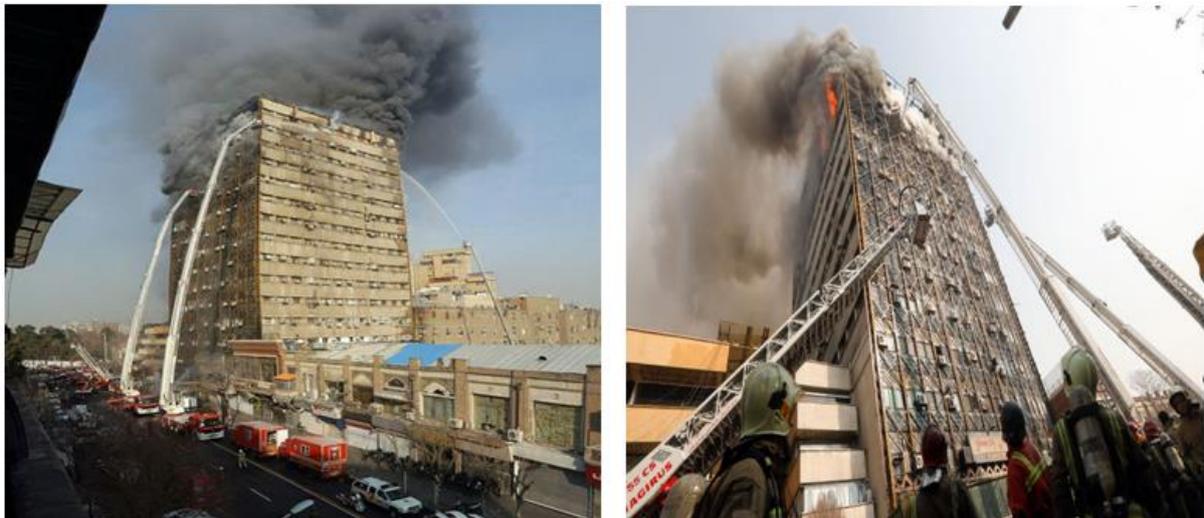
This fire is placed in the groups that the fire skyscrapers or high rise fire is said. These fires usually affect the structure of high-rise buildings and off and overcoming it requires much training and use of appropriate equipment [4]. Contrary to rumors that were launched after the September 11 attacks, the Twin Towers were not the only structures that collapsed due to fire. There is a long list of high-rise buildings have taken down due to a fire. Inhibition of fires such buildings, important points must be met. According to a spokesman for the fire department and safety services of Tehran Municipality Seyyed Jalal Maleki A total of 200 firefighters with 15 water tankers and three lifts aided fire Suppression Operations in Plasco's building (Fig 2).

Fig. 2- Plasco incident pictures [4]

Use of water for Extensive firefighting in buildings with steel structure is a strategic mistake. Water in addition to adding the building weight, also, causing thermal shock too. In particular, this shock is high in the clothing distribution center. Because of textiles, fire quickly spread and the temperature rises quickly. This will affect the steel structure of building and if the temperature will not collapse the building alone, pouring cold water on the molten metal to cause shock and thermal stress on them. In this way, may be some key components of structures bend, twist or cut under shock and weight gain caused by water. In this way a chain reaction that "progressive collapse" is known to occur. What makes the key components of the structure is disrupted and the shock of the collapse of the upper classes will disrupt components of the lower classes. So, the event is determined that the classic example is the Twin Towers and here in Tehran Plasco building. In the design, structures must be designed with not progressive destruction. Better designing of steel structure connections is one of the strategies to prevent progressive destruction.

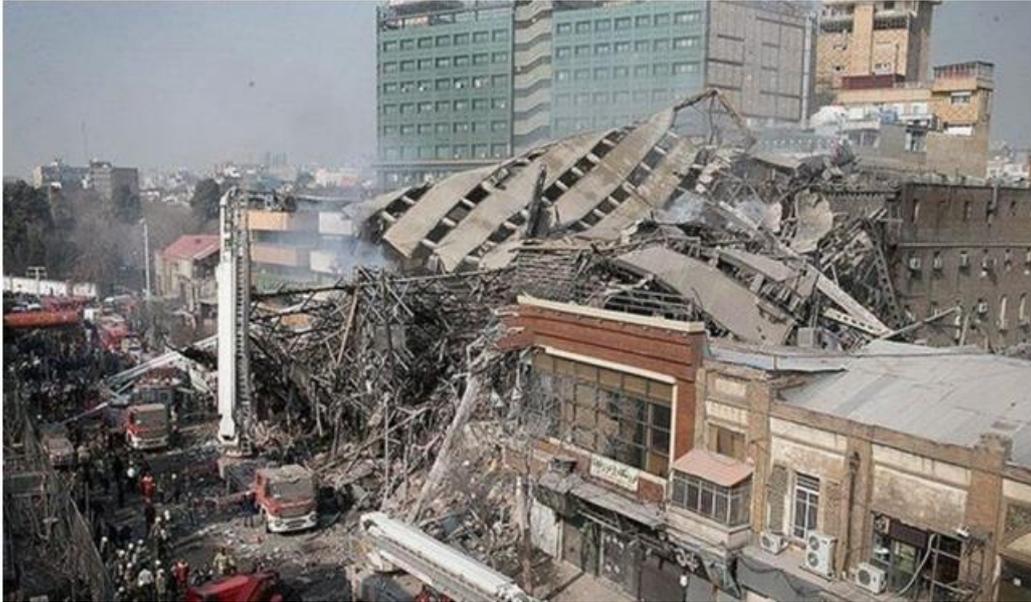
Old structures of Plasco building was lack of fire proof cover. Materials researchers showed that the metal parts of these structures in the heat and splashing water was collapsed. It does not require steel used in metal structures melt because in high heat metal behavior changes against the force. This seems a combination of temperature, thermal shock, lack of safety (causing a second explosion), the increase in weight because of water; fatigue steel structure and the absence of anti-heating cover caused to collapse buildings due to fire (Fig 3).

Fig 3. Plasco Building demolition [4]
