Shot firing the Plasco Building and Reasons for the collapse

Seyed Mohammad hosein kataeian¹, Mohsen Gerami^{2*}

¹ MSc Student of Earthquake Engineering, Department of Earthquake Engineering, Semnan University, Iran

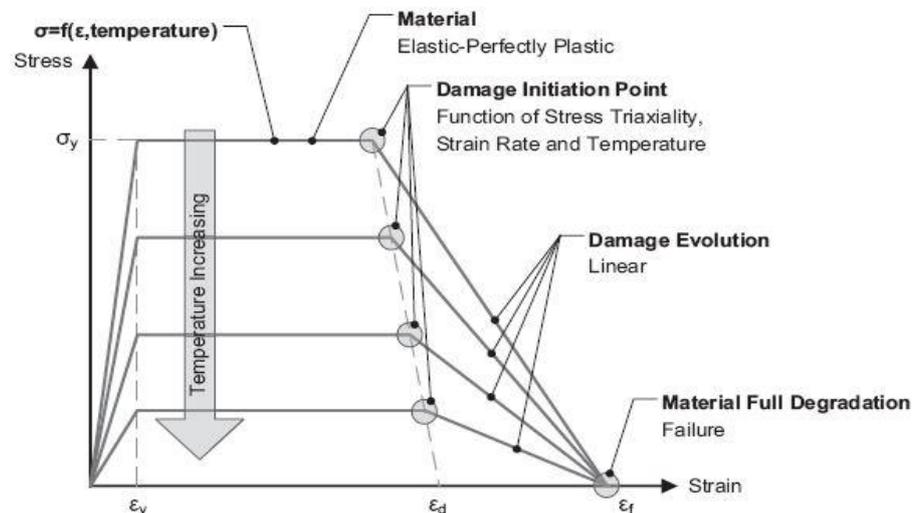
In High-temperature, steel behavior is radically different to the extent that the strength of steel at a temperature of 600 ° C loses half of its strength (Fig 1).

Fig 1: steel resistance changes with rising temperature [1]
